TRANSPORTATION RESEARCH CENTER

**ON-SITE AIR BAG INVESTIGATION**

CASE NO. - 95-18  
FLEET - COMMERCIAL VEHICLE  
LOCATION - [REDACTED] PENNSYLVANIA  
ACCIDENT DATE - [REDACTED] 1995

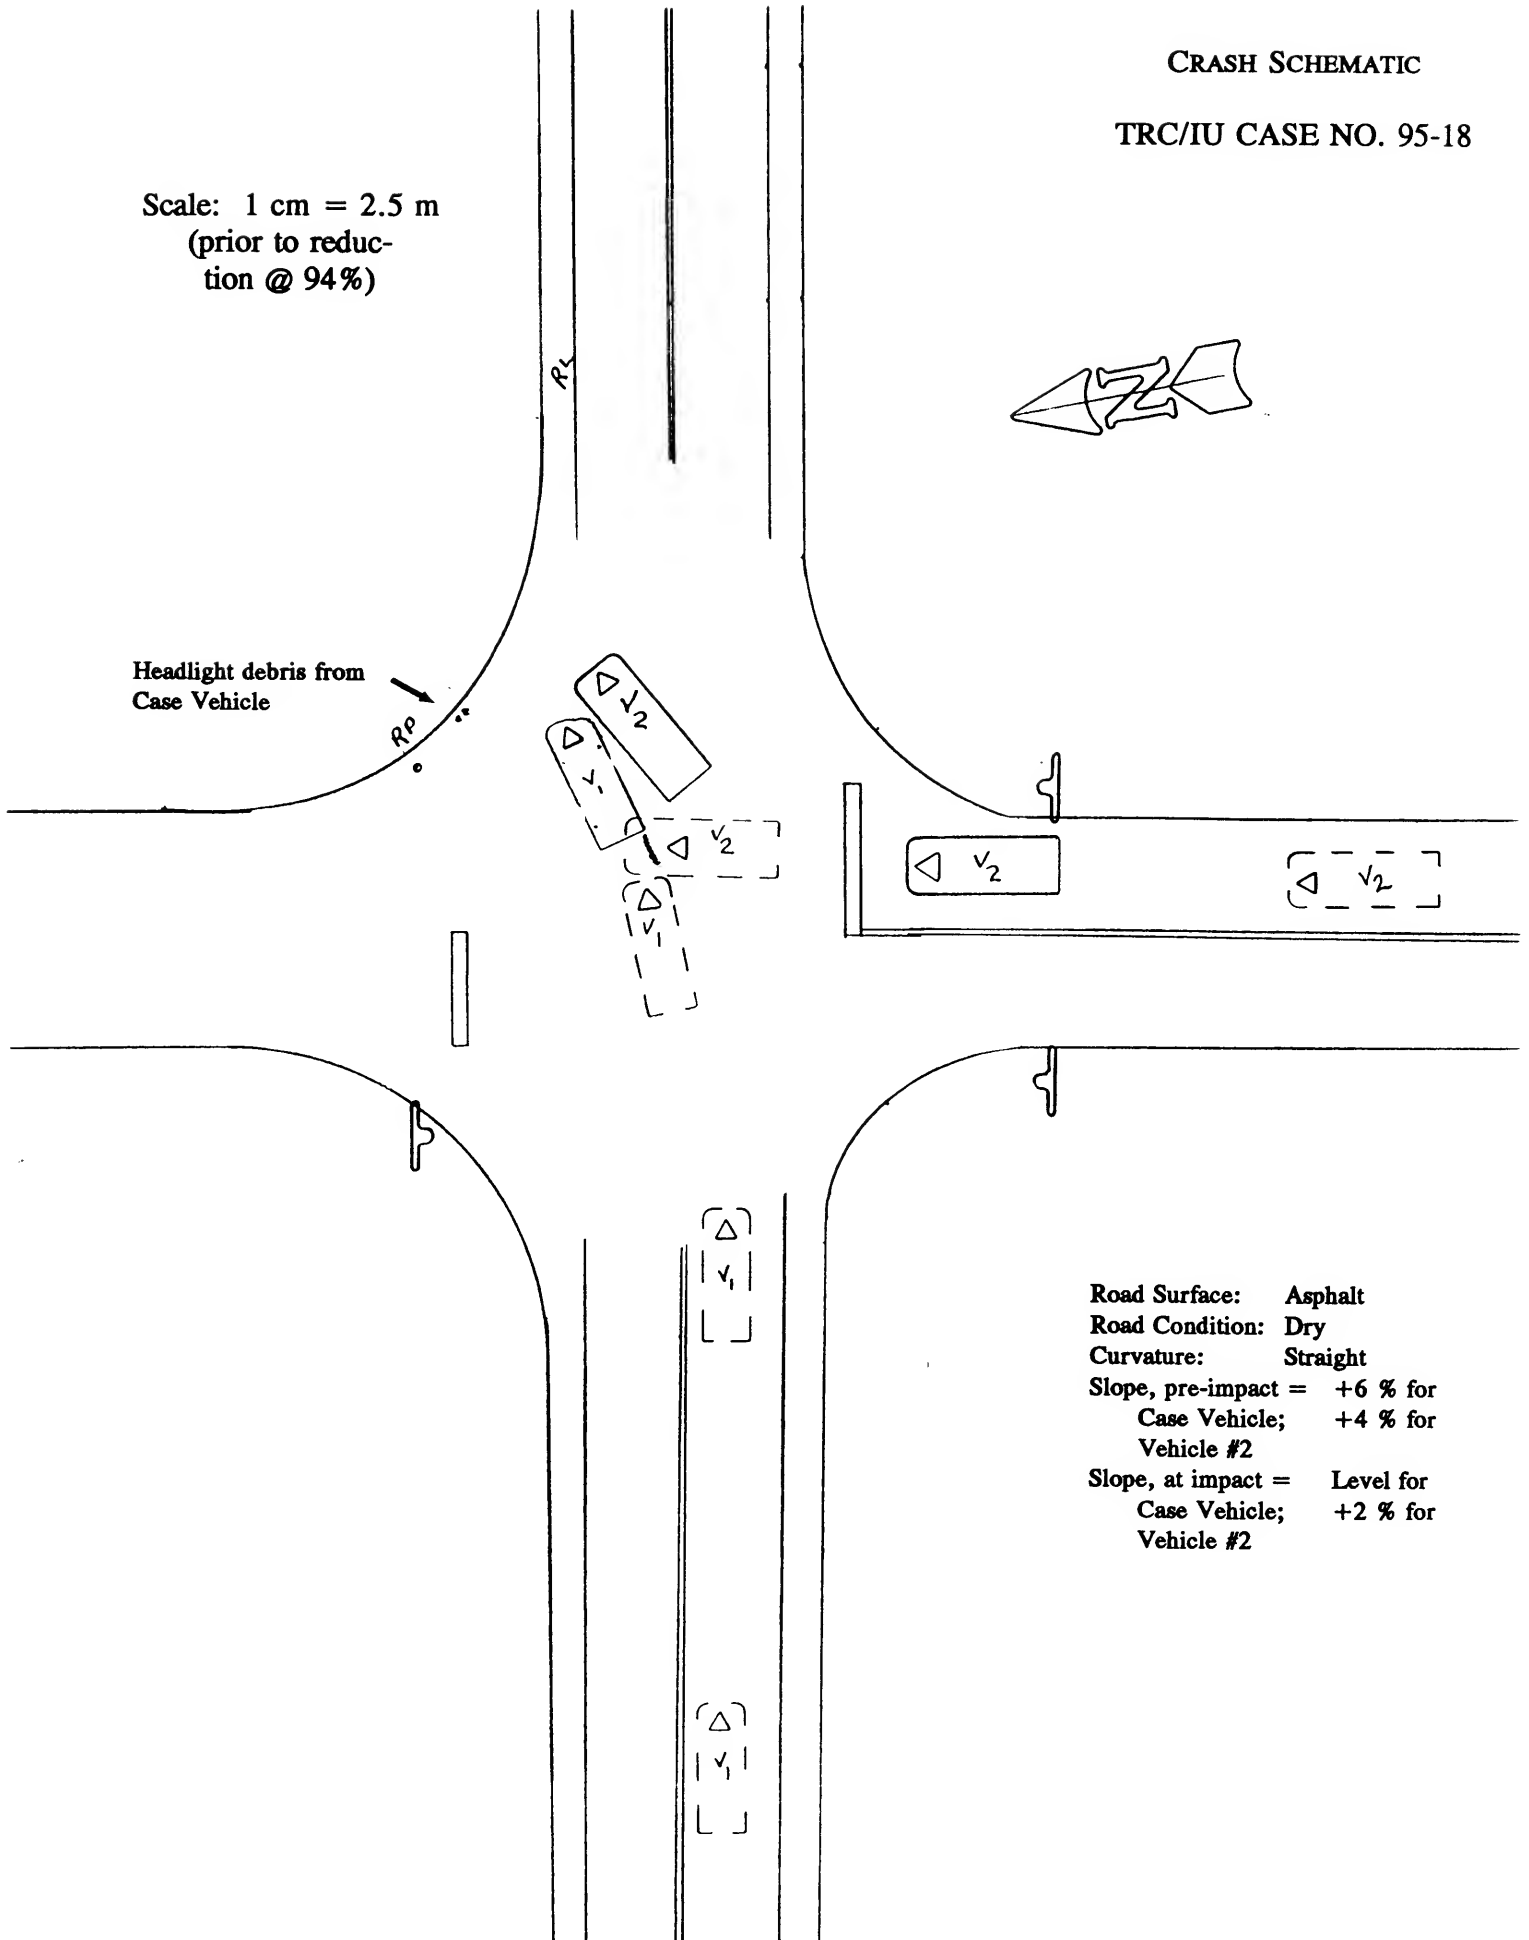
TRC/IU CASE NO. 95-18

Scale: 1 cm = 2.5 m  
(prior to reduction @ 94%)

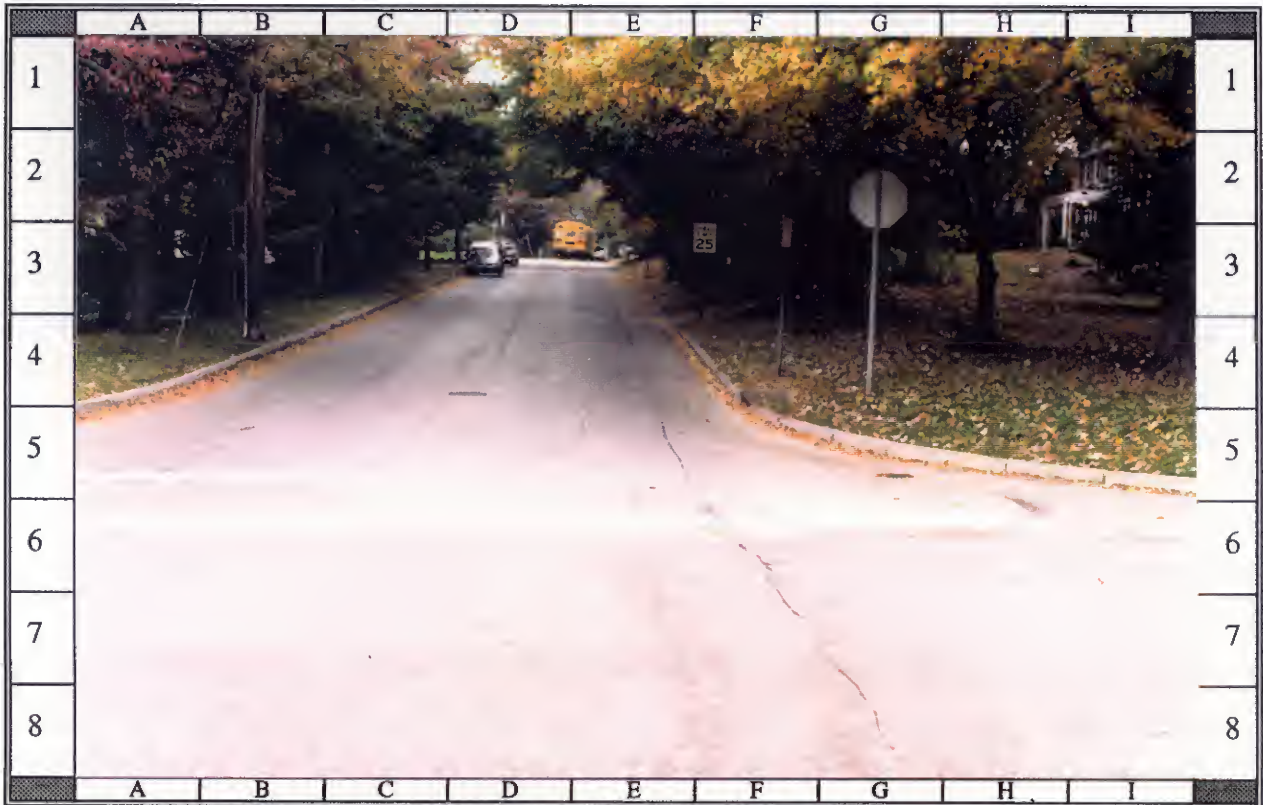
# 8 -- Vehicle #2's northward travel path in northbound lane ~ 15 meters (49 feet) south of impact

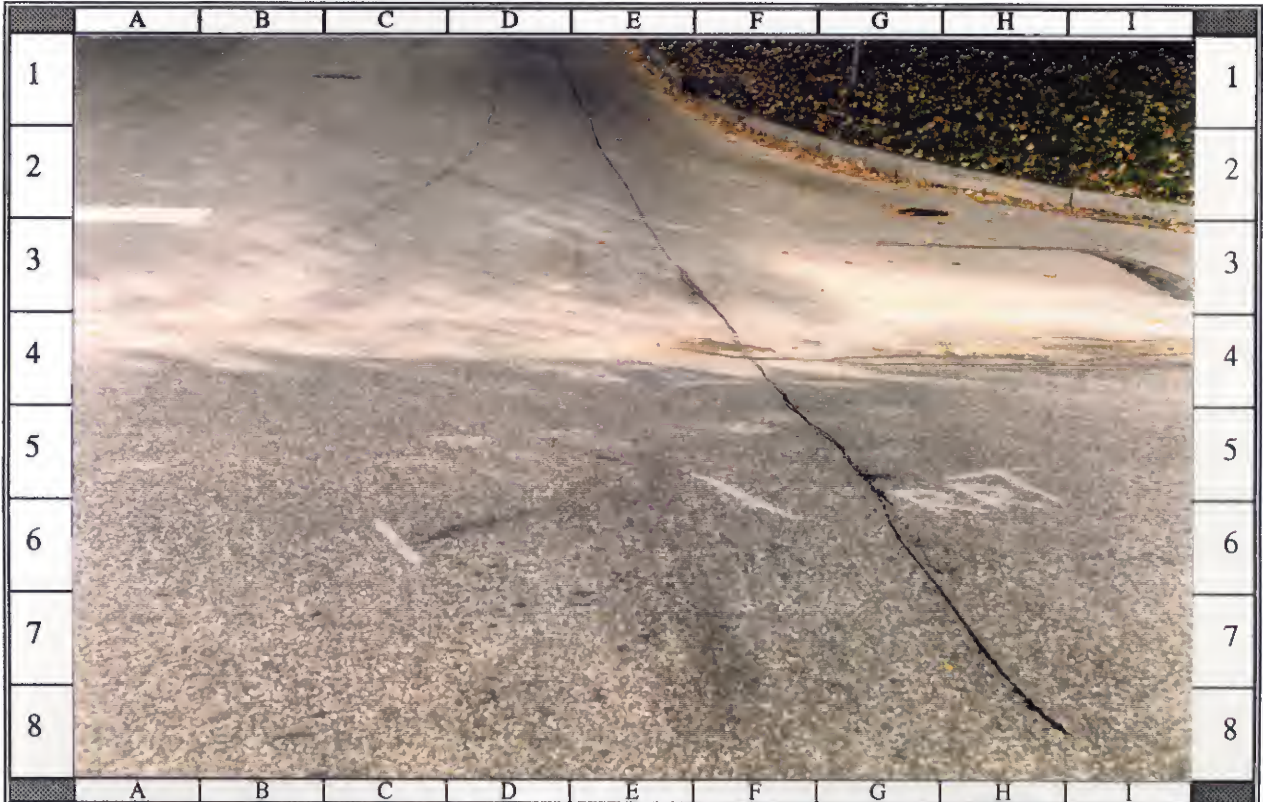
**# 9 -- Vehicle #2's northward travel path in northbound lane ~ 5 meters (16 feet) south of impact**

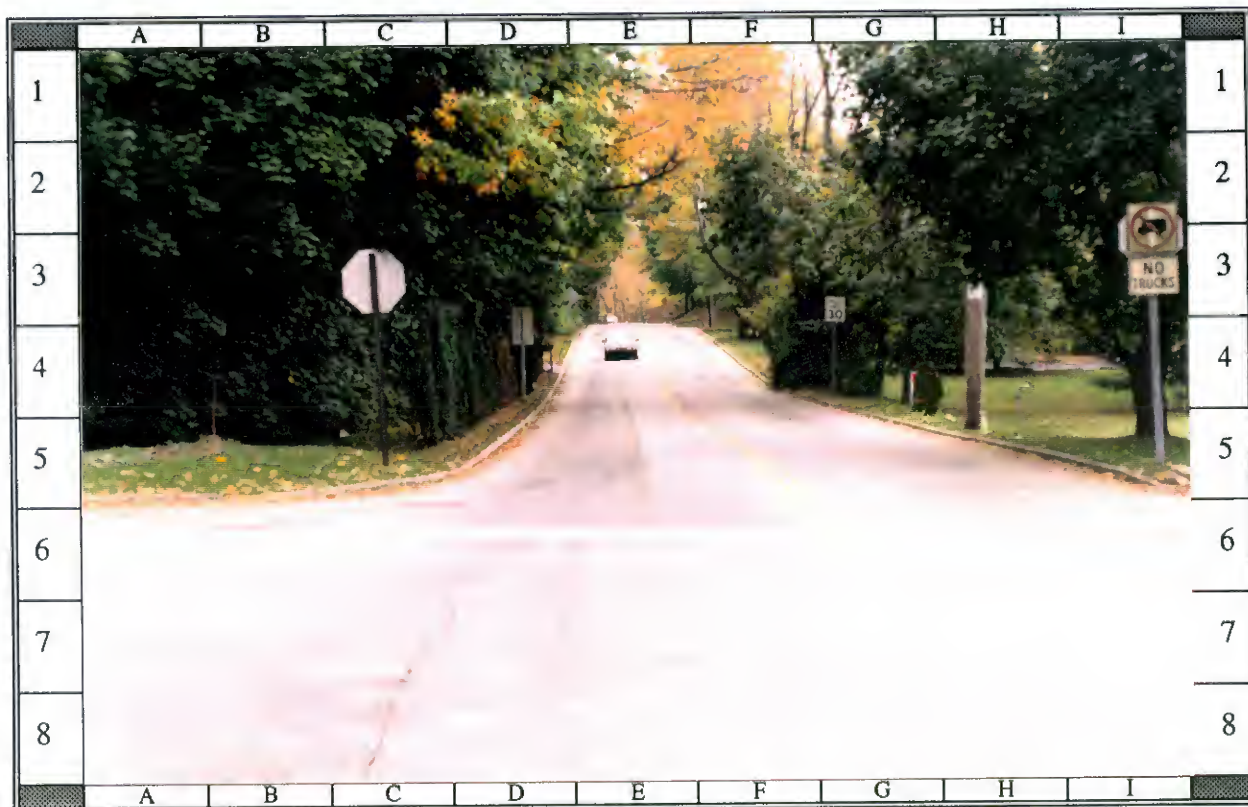
# 12 -- South-southwest view of Vehicle #2's northeastward travel path from impact to final rest

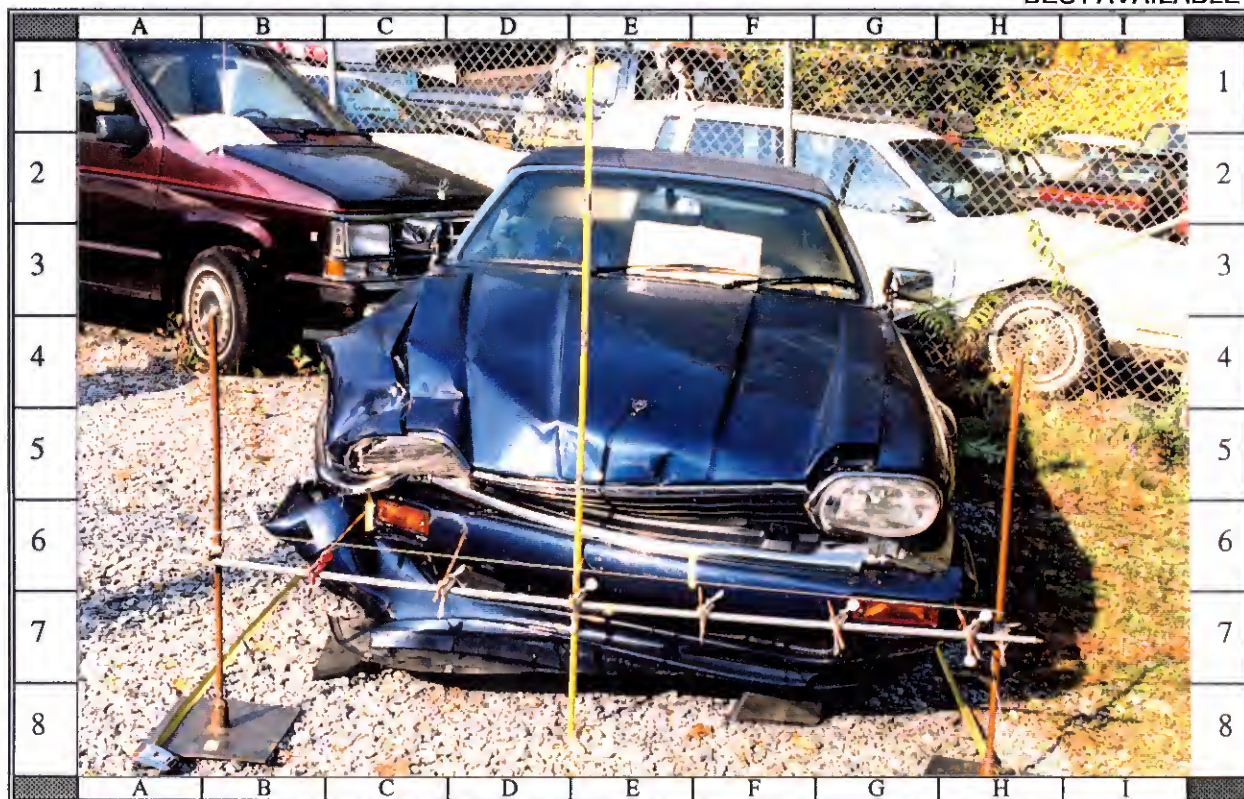
# 14 -- 1995 Jaguar XJS's damaged front without contour gauge

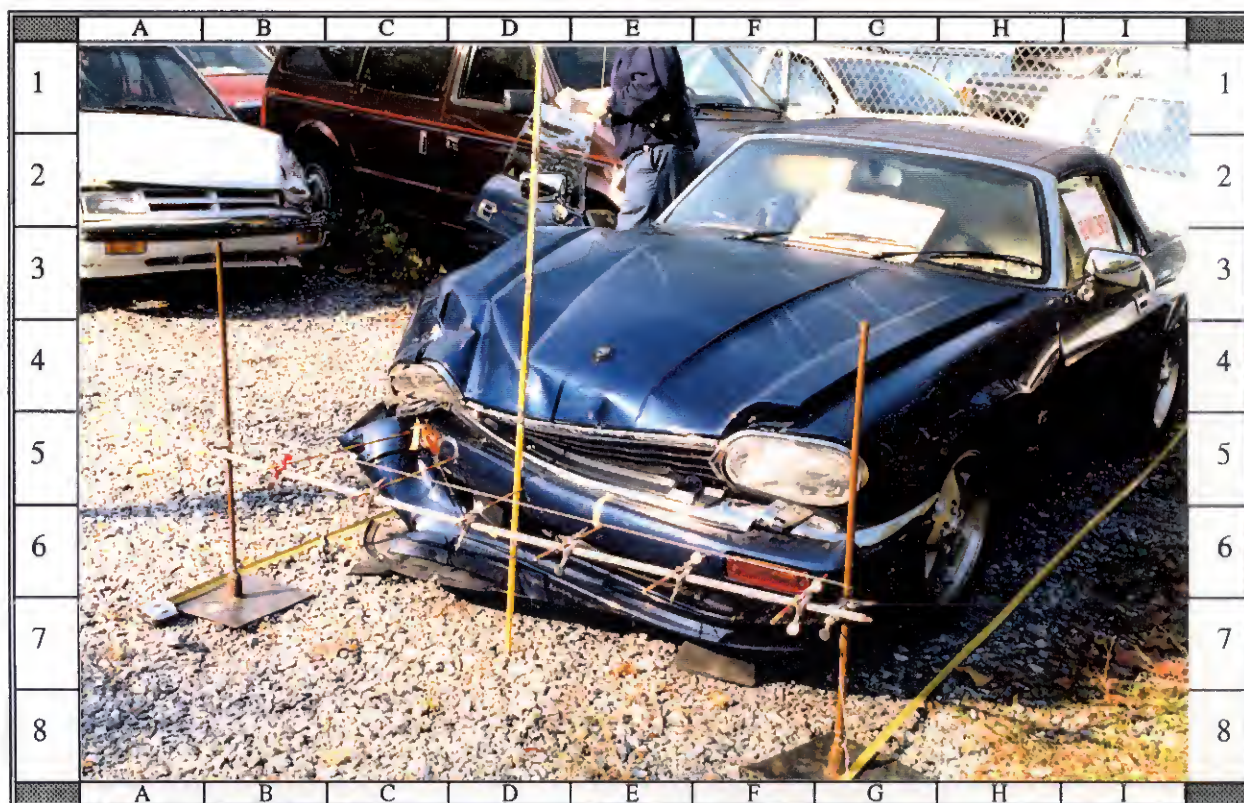
# 15 -- Case Vehicle's damaged front with contour gauge present

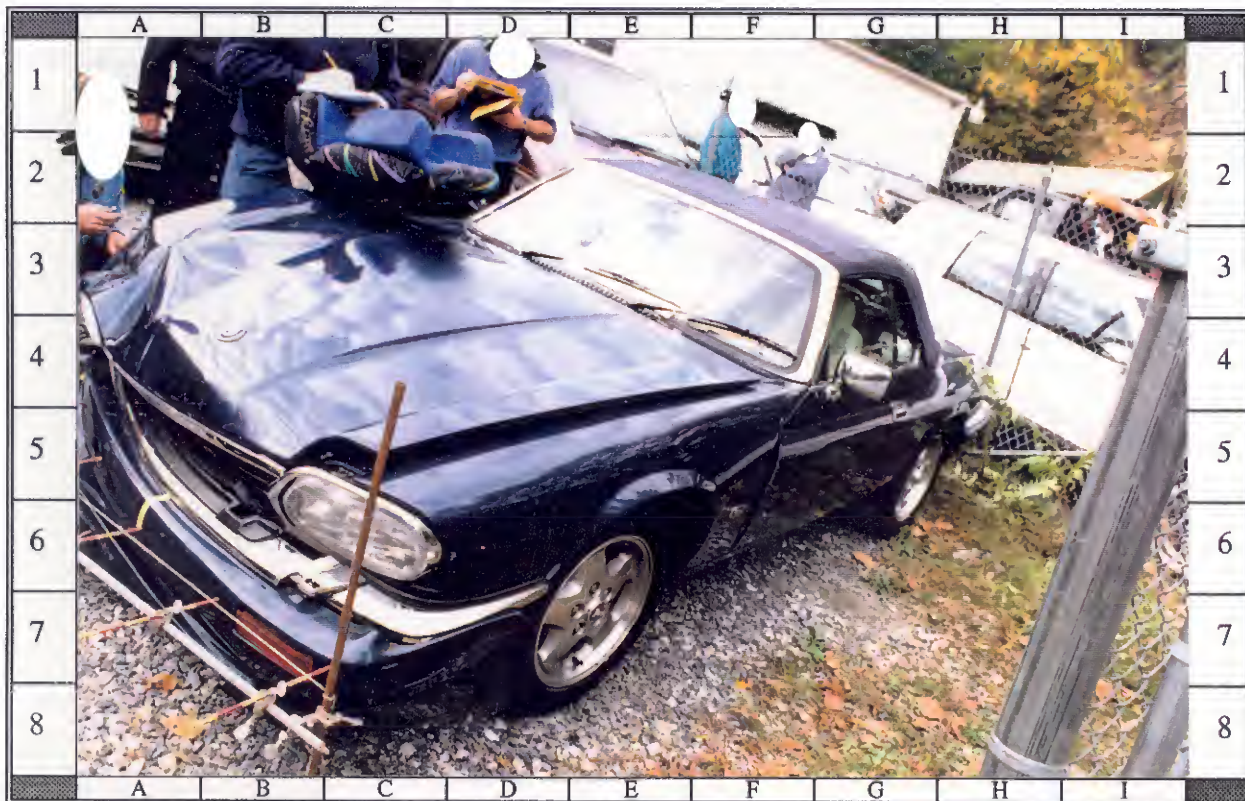
# 16 -- Case Vehicle's damaged front viewed from approximately 30 degrees left of front with contour gauge present

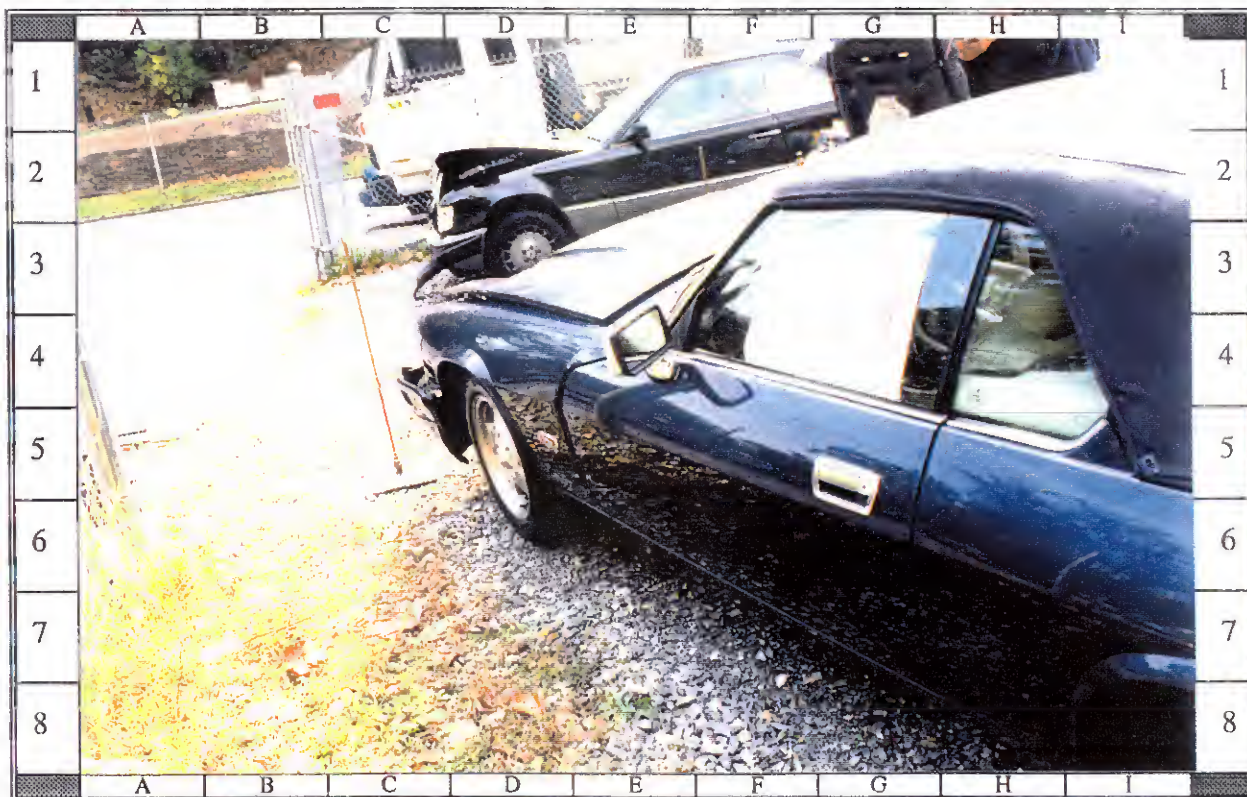
**# 18 -- Reference line view of Case Vehicle's front damage from left with contour gauge present; NOTE: left bumper corner induced outward**

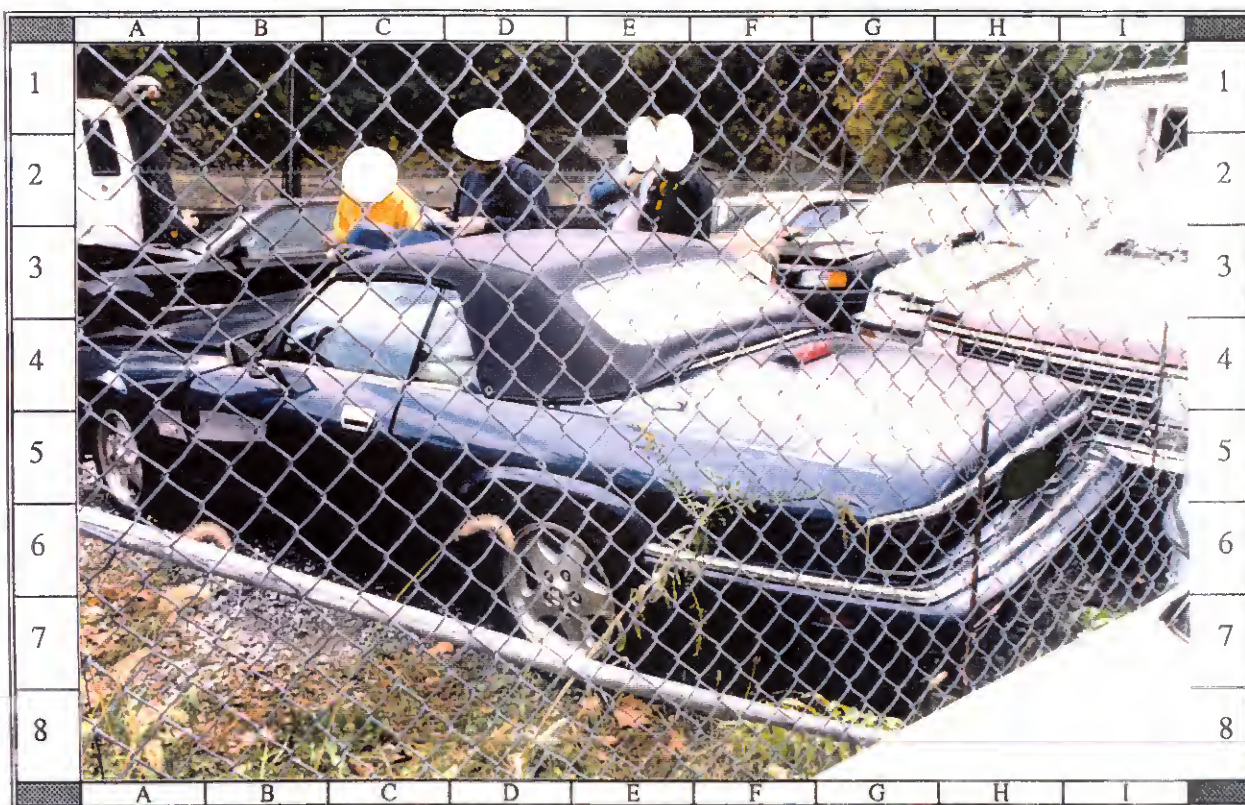
# 19 -- Case Vehicle's essentially undamaged (i.e., no direct damage) left side viewed from approximately 30 degrees left of back

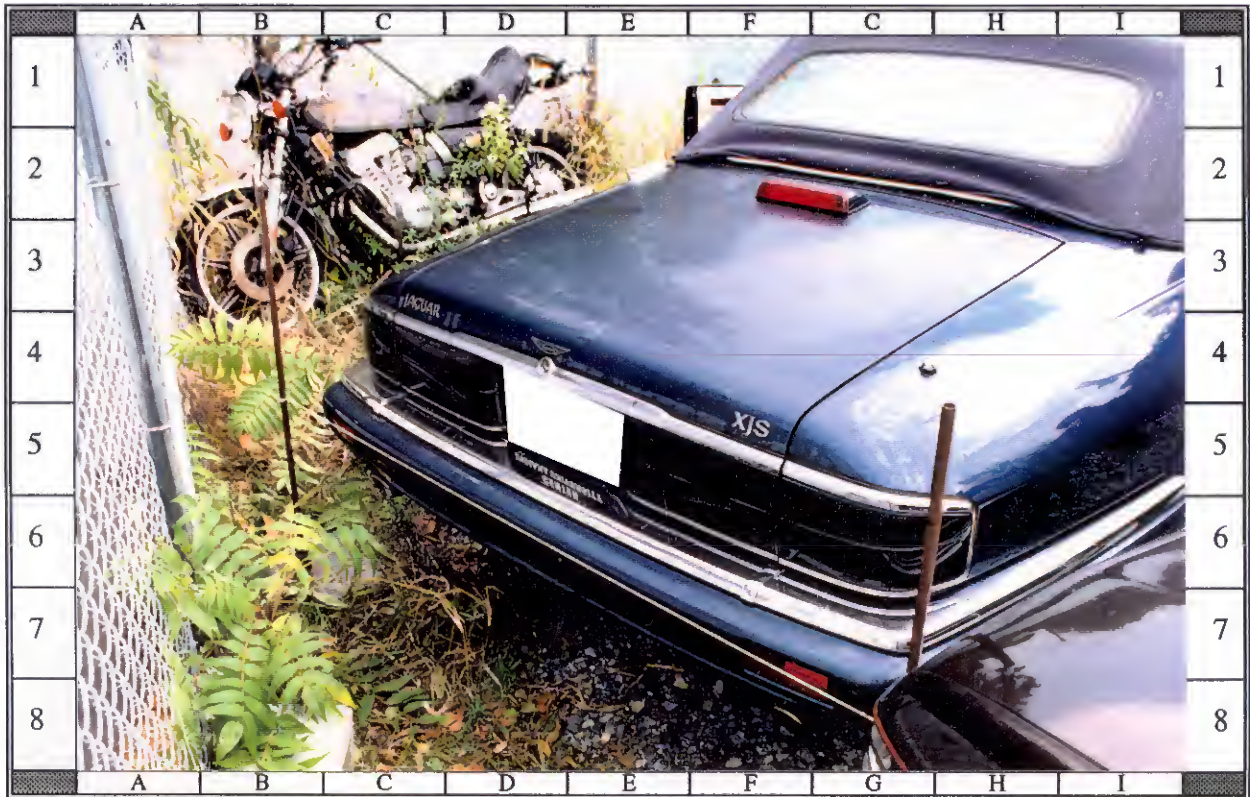
# 20 -- Case Vehicle's essentially undamaged (i.e., no direct damage) left side and back viewed from approximately 60 degrees left of back

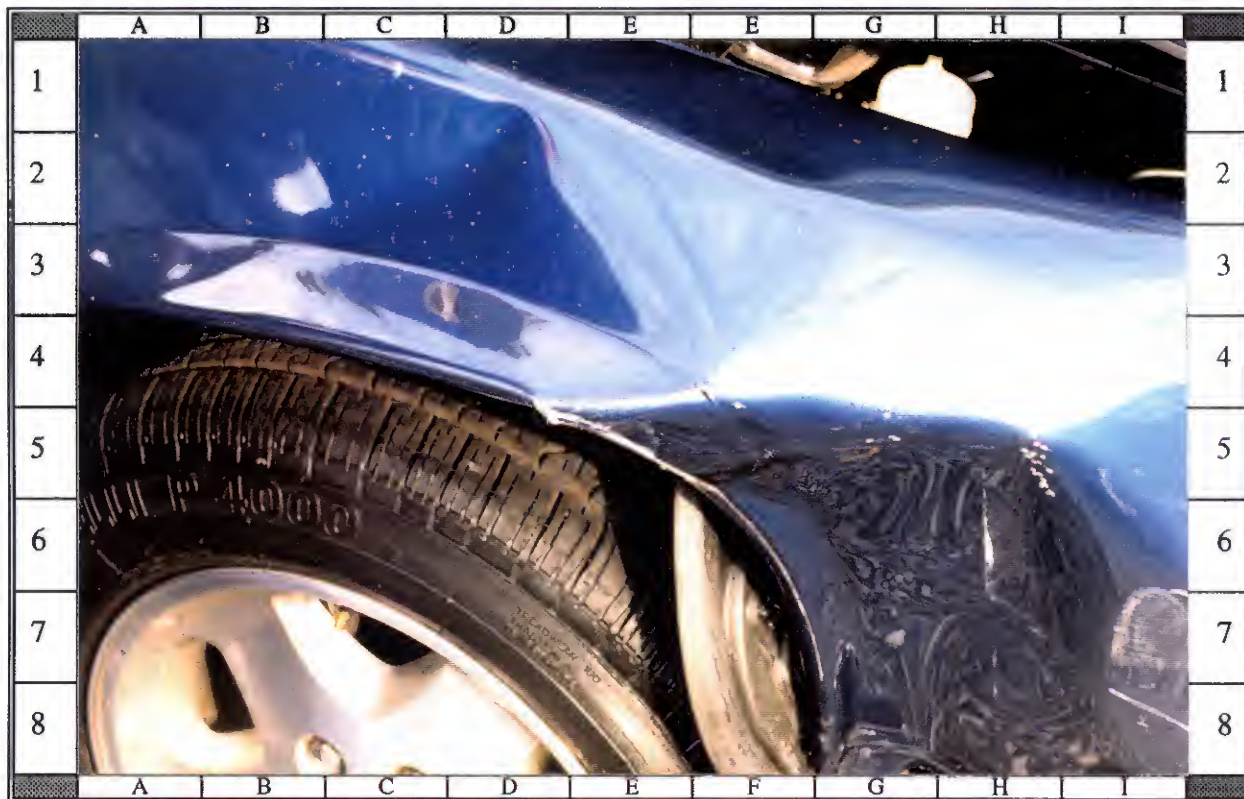
# 22 -- Case Vehicle's right front fender showing restricted right front wheel and direct contact to rim (cells B7--C8)

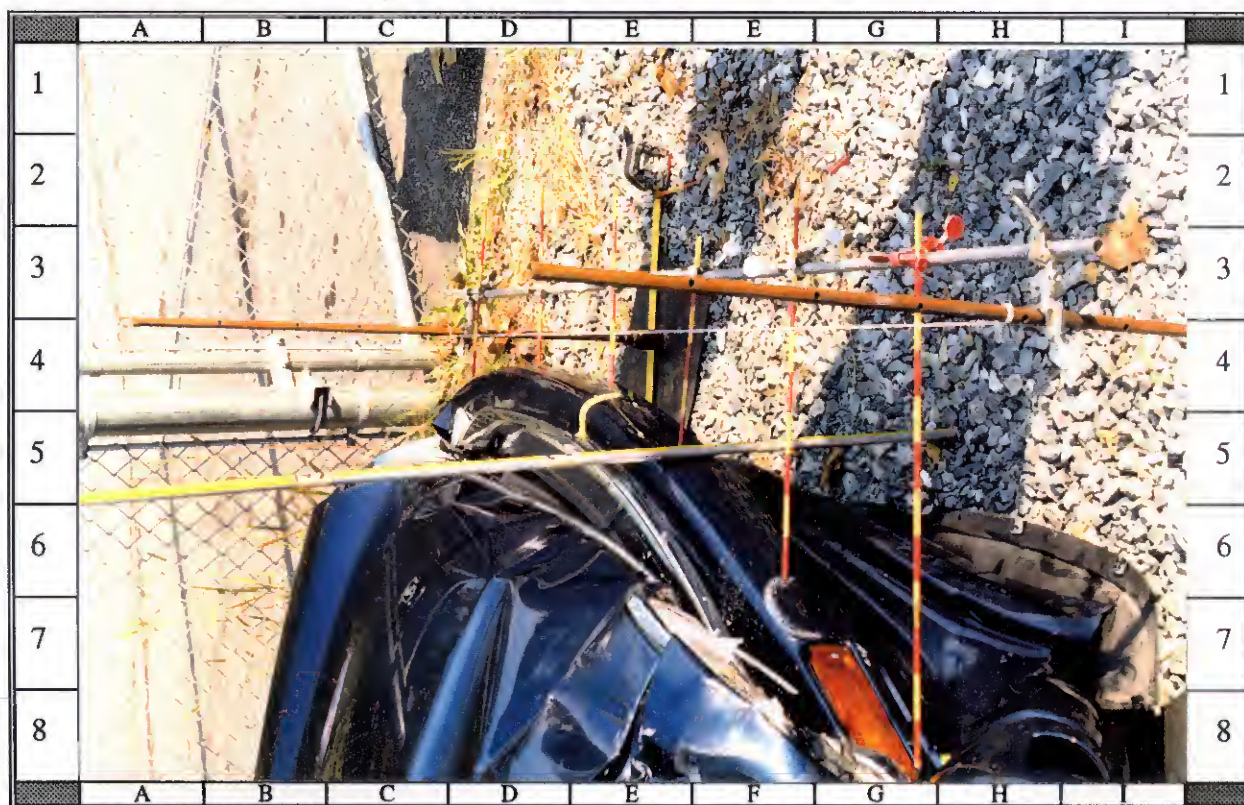
# 23 -- Close-up of direct damage to Case Vehicle's right fender (cells D5--E5) which occurred during rotation to final rest with Vehicle #2

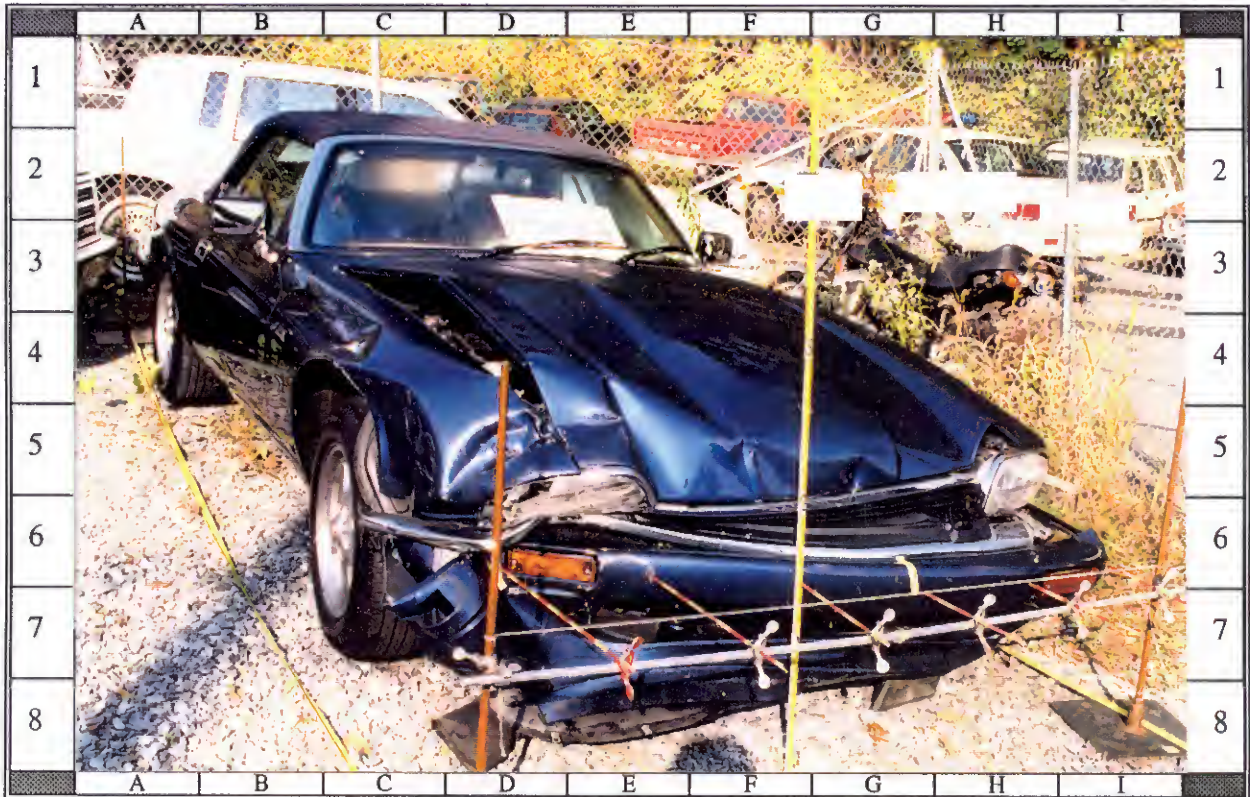
# 24 -- Reference line view of Case Vehicle's front damage from right with contour gauge present; NOTE: maximum crush occurs at C<sub>6</sub>

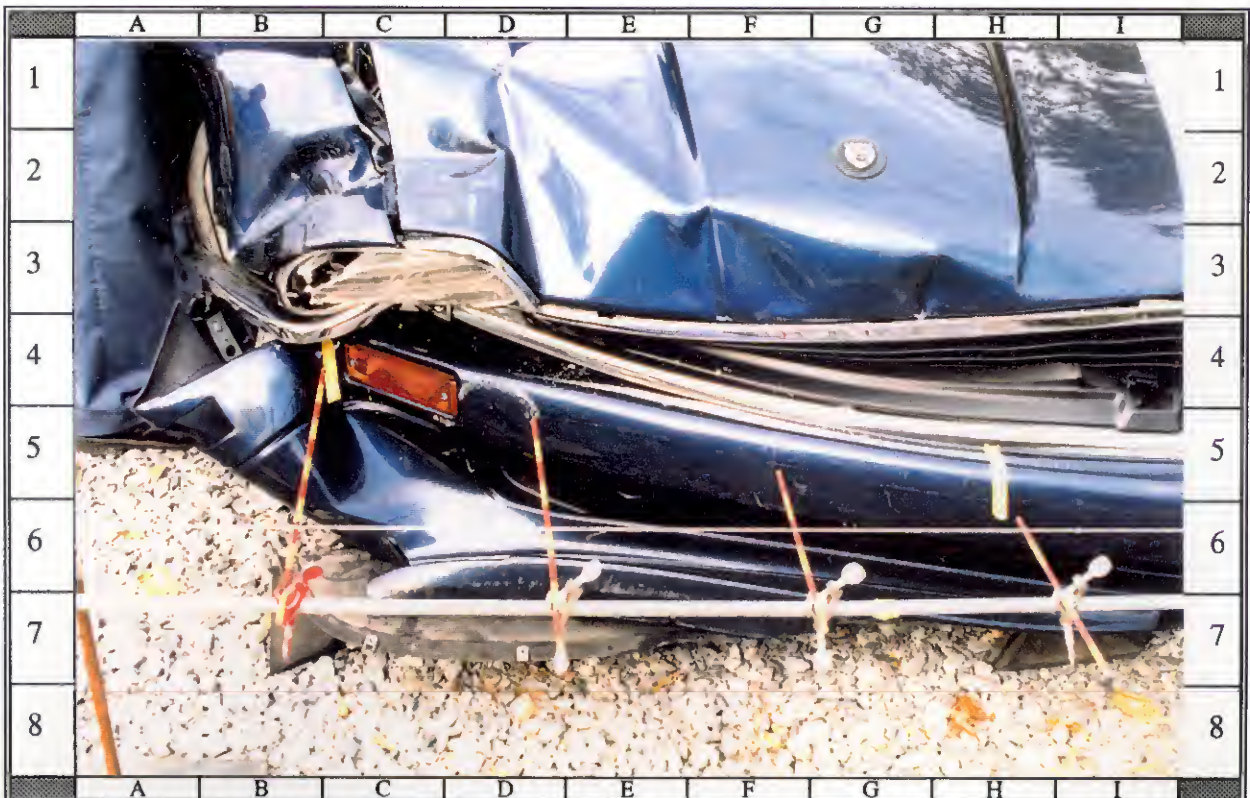
# 25 -- Case Vehicle's frontal damaged viewed from approximately 30 degrees right of front

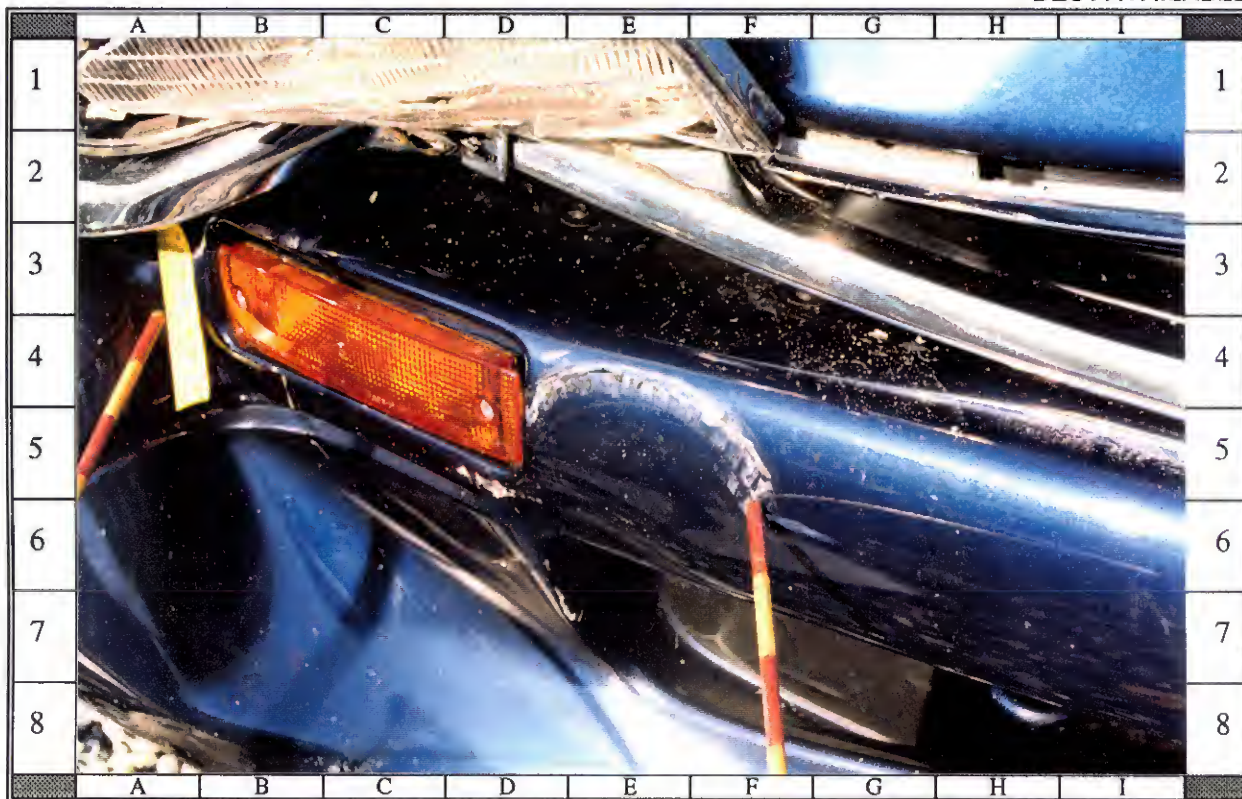
# 26 -- Close-up of direct damage to front right of Case Vehicle; NOTE: yellow tape indicates width of direct damage

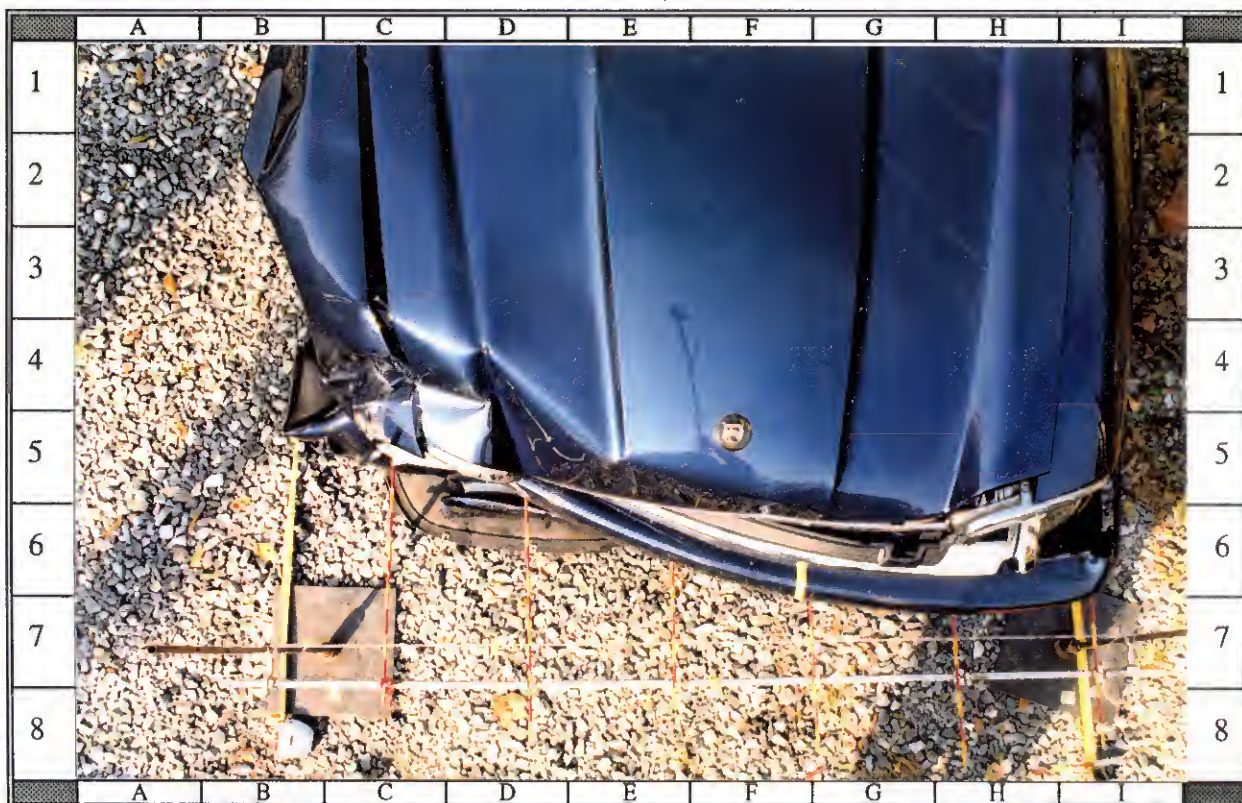
**# 27 -- Close-up of imprint on Case Vehicle's damaged front bumper from Vehicle #2's left front hubcap (see PHOTO #62)**

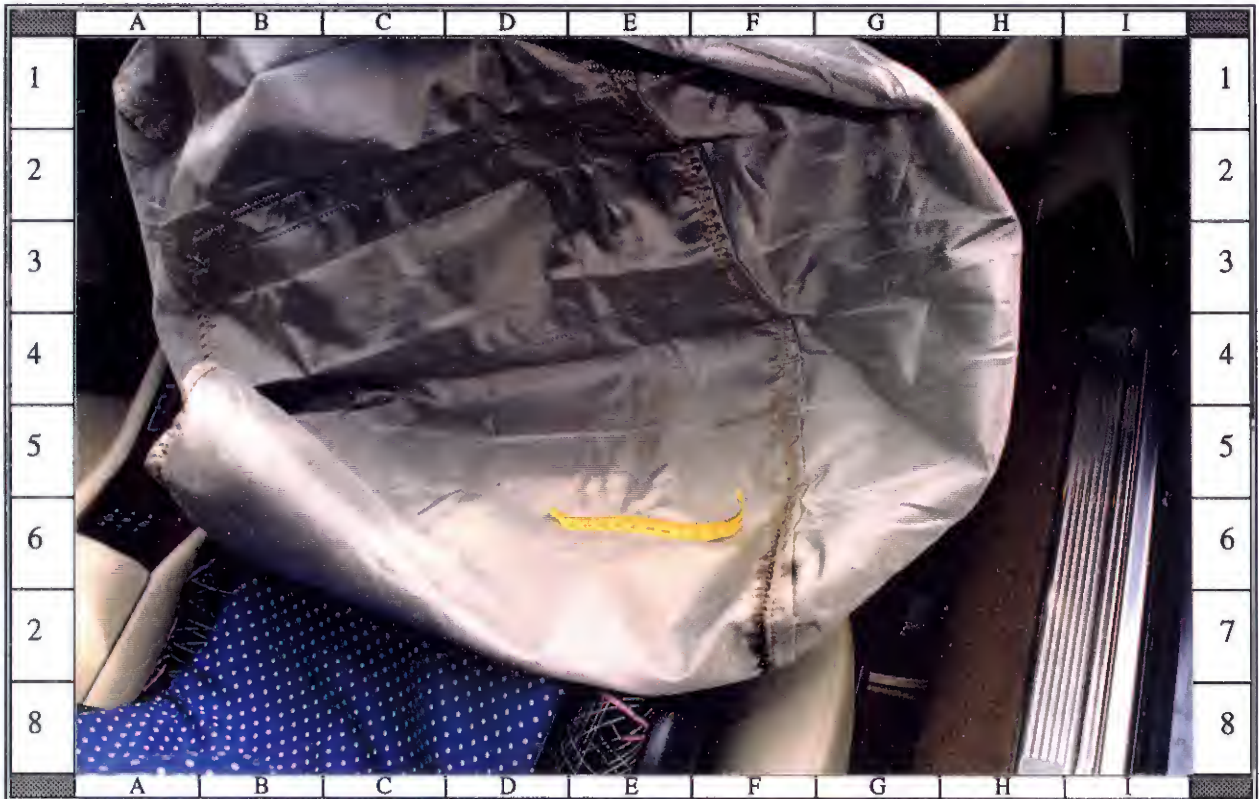
# 36 -- Close-up of contact evidence on Case Vehicle's right front passenger air bag;  
NOTE: blood spot (cell E5)

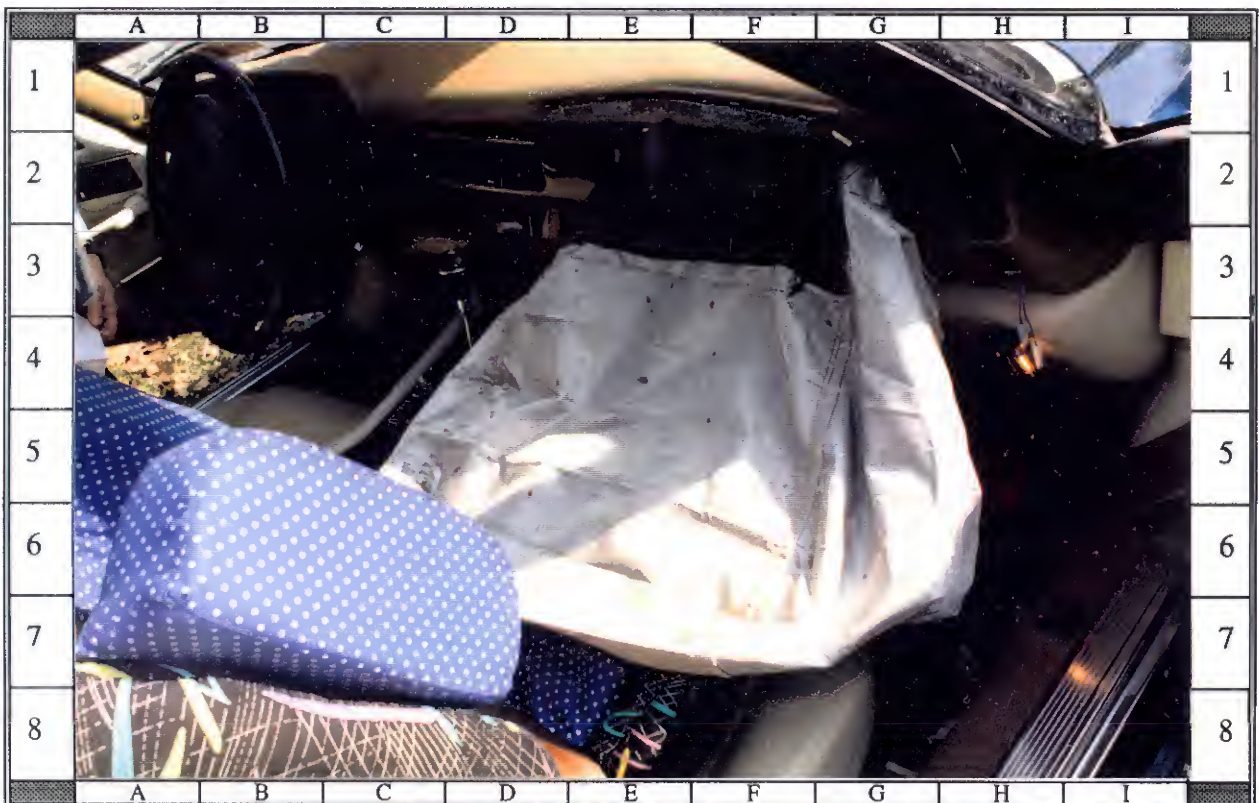
# 37 -- Topdown view of Case Vehicle's right front passenger air bag showing singeing to lower right seam below contacted area

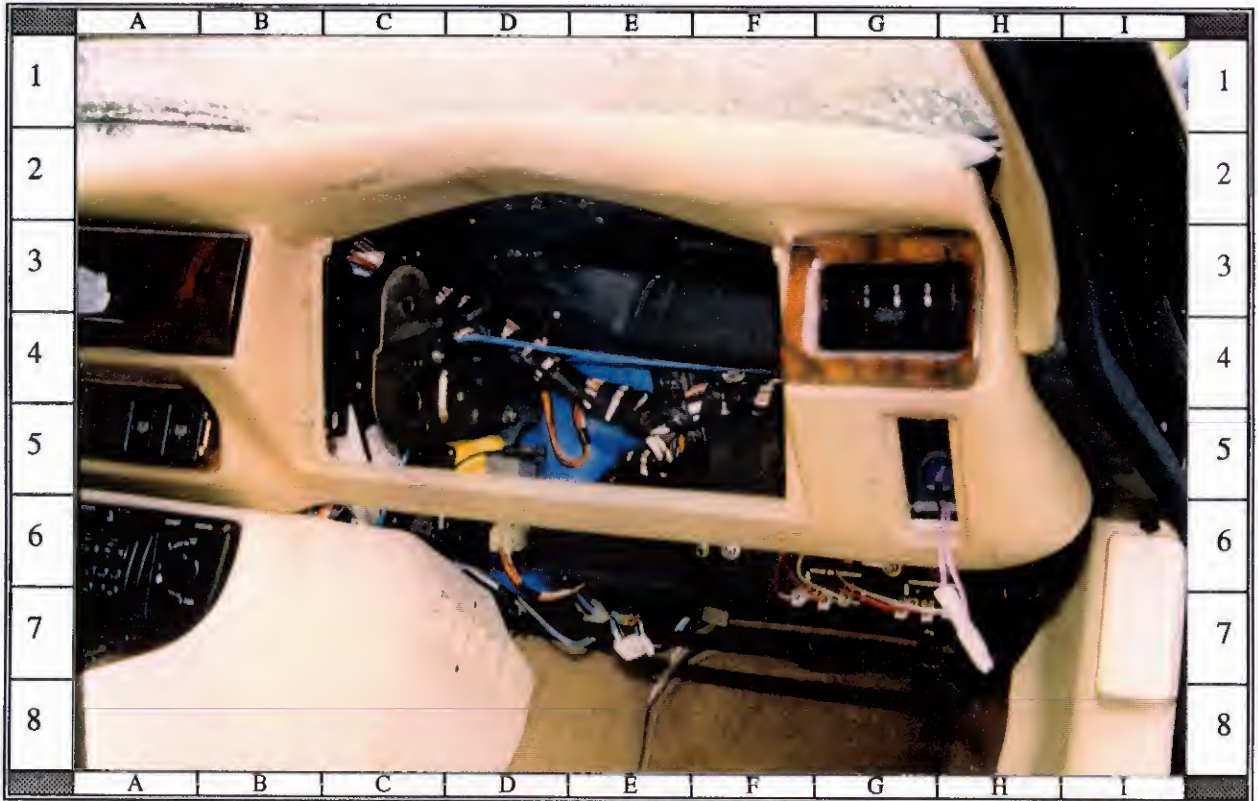
# 38 -- Top portion of Case Vehicle's right front passenger air bag; NOTE: top cover flap (facia) deformed dash (cell E1--F1)

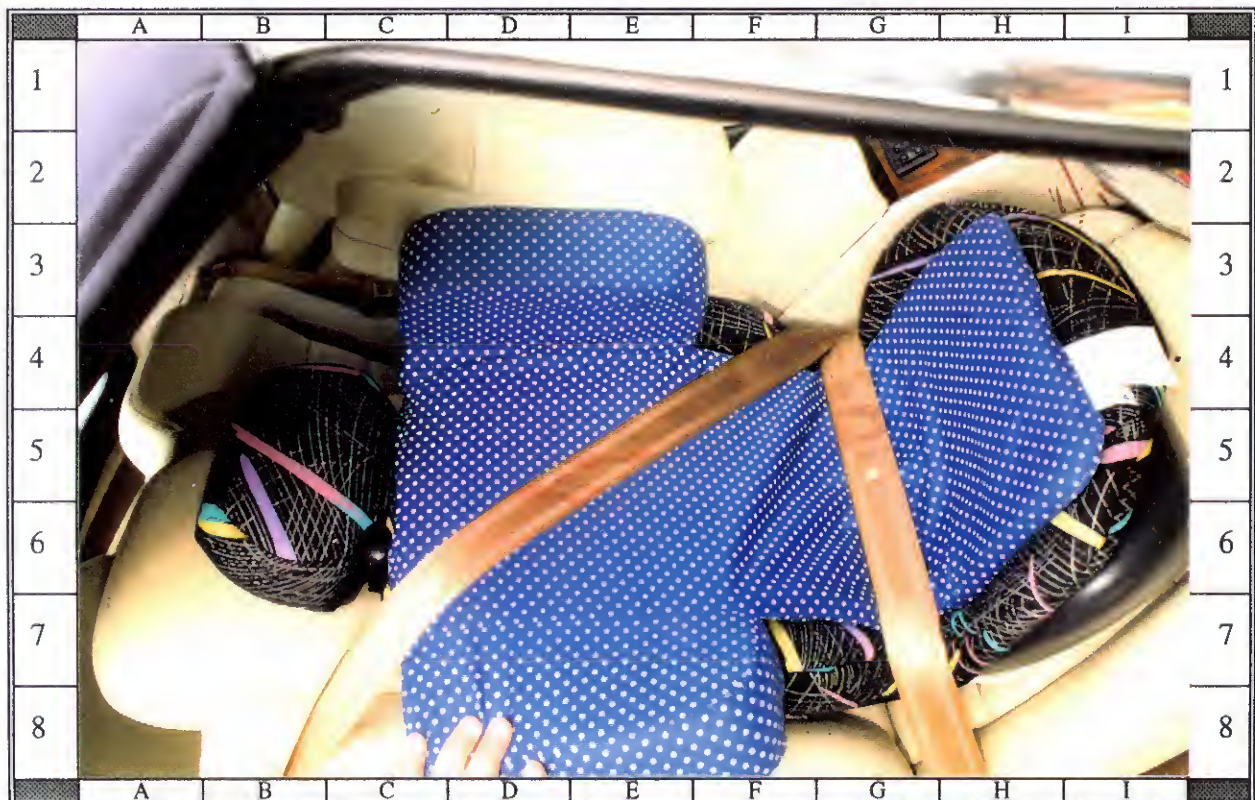
**# 45 -- Case Vehicle's right front seat with child's booster seat and seatbelt fastened;  
NOTE: blood on belt (cells E4 and F6)**

In this contractor's opinion<sup>5</sup>, the child's posture prior to the driver's avoidance maneuvers was: he was half asleep--as the driver stated, and most likely was leaning to his left with his head turned to the left away from the torso portion of his 3-point lap and shoulder belt which he was wearing at the time of the crash. The child's belt use was confirmed during the interior vehicle inspection. Blood drainage stains from the child's nose were found on both the lap and torso portion of the belt restraint system (see **SELECTED PHOTOGRAPHS #45 through #47**).
